**Anchor Home Inspection**  
16 Deer Trail  
Oakdale CT 06370  
860-961-3213  
AnchorHomeInspection@gmail.com

**Inspection reference: Sample**

# **Confidential Inspection Report**

**July 1, 2025**

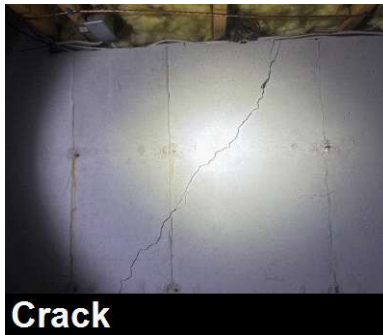
The below grade space is a poured concrete basement with a concrete floor. There are minor vertical foundation shrinkage or settlement cracks. This type of crack is usually not a structural concern unless the crack is wider than approx. .25", the crack is uneven, or the concrete is displaced on either side of the crack. They often allow exterior water to seep into the basement or crawl space. **You should have all cracks sealed by a specialist to prevent water seepage.**

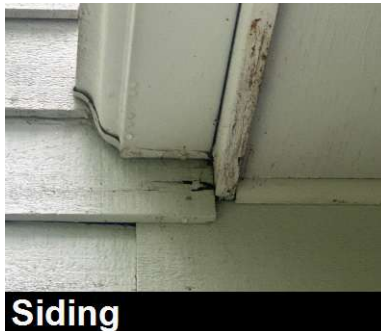
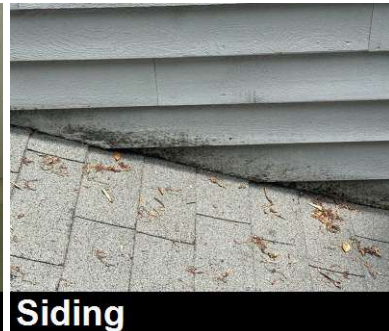
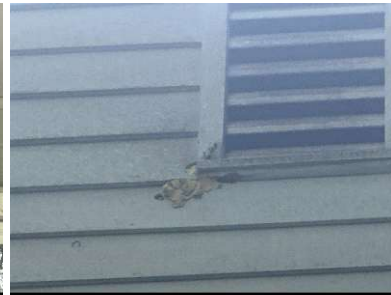
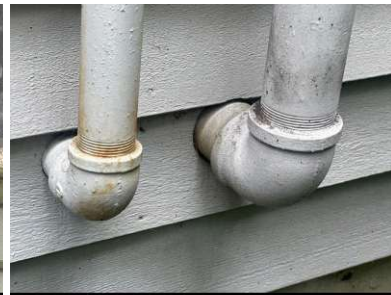
**Siding**

The exterior wall surface is wood board siding. **Sealant is missing or deteriorated where the utility wiring and piping run through the exterior wall. This sealant is necessary to prevent moisture intrusion. You should seal these areas with a sealant suited for this location and use. The siding is damaged at one or more locations. Siding is the protection for the building and any damage or deterioration could allow moisture and weather intrusion, causing further damage and expense. The siding material should be repaired or replaced as needed to make a weather-tight envelope for the building. There is inadequate clearance between the siding and the roof surface. This may allow water to wick into or behind the siding. You should have a qualified contractor trim the siding to give adequate clearance. The paint/stain coating is deteriorated at several locations along the walls. Paint and other coatings are a barrier to help protect the substrate from deterioration due to sunlight and weather elements. A coating should be properly applied to the surfaces in need. The siding is rotted at one or more locations. Siding provides protection against the weather for the structure and interior of the building. The rotted areas should be replaced or repaired permanently with proper materials. There have been amateur repairs at the siding. You should monitor these areas.**

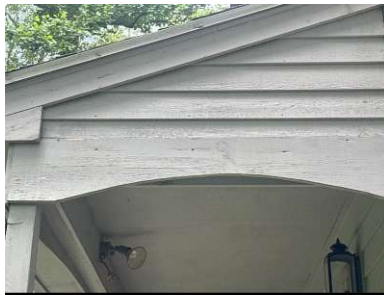
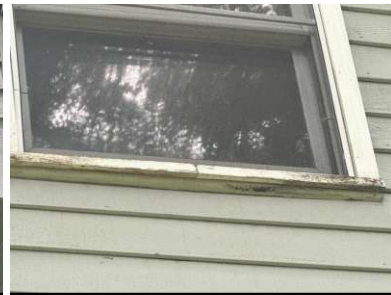
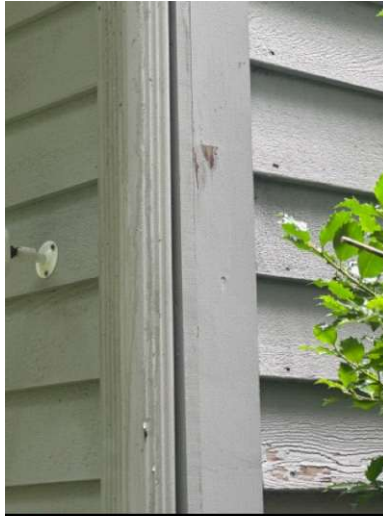
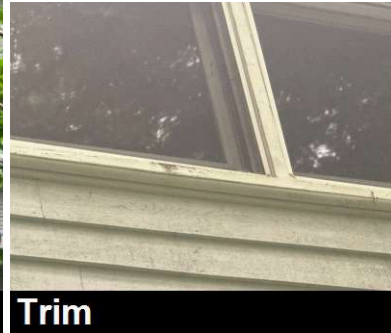
**Trim**

The exterior trim is wood. The paint coating is deteriorated. Paint and other coatings are a barrier to help protect the substrate from deterioration due to sunlight and weather elements. A coating should be properly applied to the surfaces mentioned.

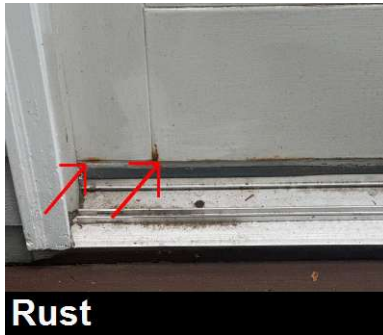
There are metal exterior doors. The metal exterior entry door is rusted. You should repair or replace the door.

**Rust**

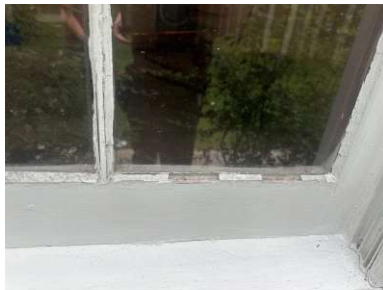
There are wood framed windows. The window glazing putty is deteriorated. This glazing putty prevents moisture and air entry between the glass and the window frame. The old putty must be removed and new putty put in its place.

**Glazing Needed**

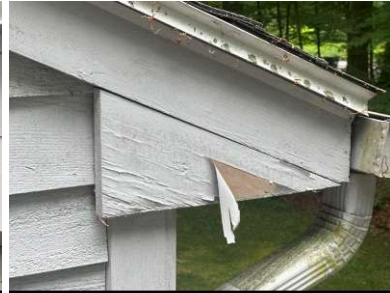
**Eaves**

The eaves are wood. There is rot at the eaves. Rotted eaves can allow the entry of moisture and pests which could cause further deterioration. The rotted portions should be repaired or replaced.

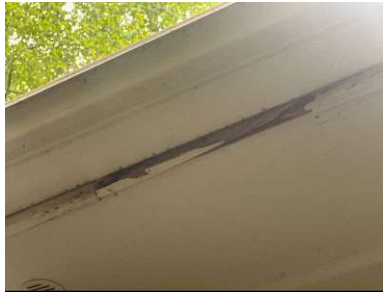
**Facias**

The fascia is wood. There are rotted sections of the fascia near . The rotted areas could allow for the entry of moisture or insects and can lead to further damage. You should have the damaged sections replaced.

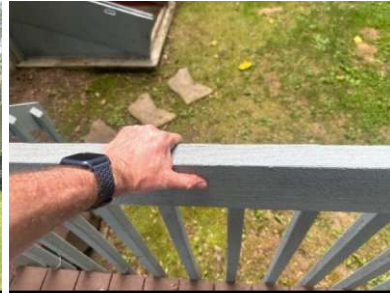
The deck railings are loose. Loose railings will not provide protection from falls. The railing should be secured or replaced.

**Loose**

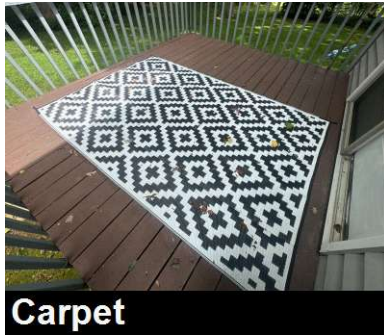
There is a deck attached to the home. The deck is carpet covered. This may trap moisture and lead to wood rot. We were unable to determine the condition of the material under the carpet.

**Carpet**

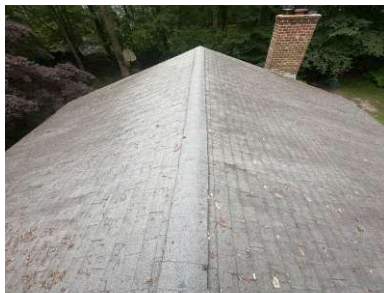
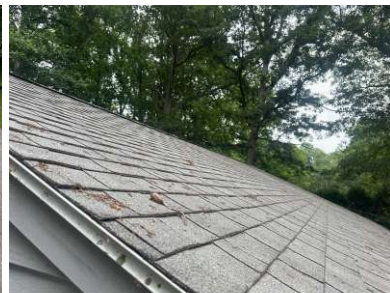
**Roof**

The asphalt shingle roof was inspected by walking on a lower roof and inspecting the upper roof from there. The roof is reported to be 19 years old. The asphalt shingle roofing shows signs of minor deterioration. This could allow moisture to penetrate the roof covering and cause damage. You should continue to monitor for the loss of granular and have the roof evaluated and repaired or replaced by a qualified roofer at the first sign of moisture intrusion. The asphalt shingle roofing has moss, lichens on its surface. This could allow moisture to penetrate the roof covering and cause damage. This should be removed to protect the shingle's granular surface. There are branches, leaves, and other debris on the roof. This will help trap moisture and increase deterioration of the roof. You should clean the roof being careful not to damage the shingle material.

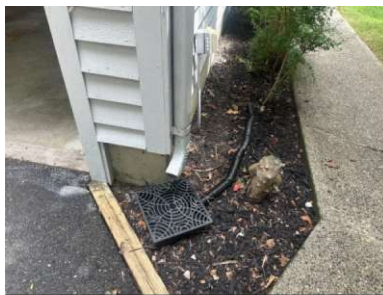
The downspouts empty close to the building foundation. This can promote water intrusion into the structure and could cause settlement of the structure itself. The downspouts must be extended to at least five to ten feet from the building, or to a distance equal to the depth of the footings at that location. The gutters are leaking at their joints. Leaking gutters will not carry the roof runoff away from the building, and may promote leakage into the structure. Leaking joints should be repaired with a caulking compound that is specifically manufactured for this purpose. The gutters and

**Extend Downspouts**

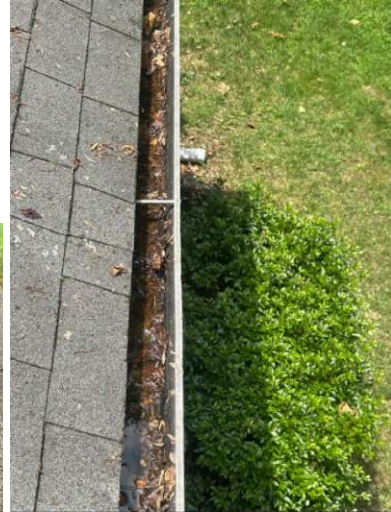
downspouts are clogged with debris. This can cause them to overflow and allow roof runoff to fall close to the building. The gutters and downspouts must be cleaned to function properly.

**Clogged**

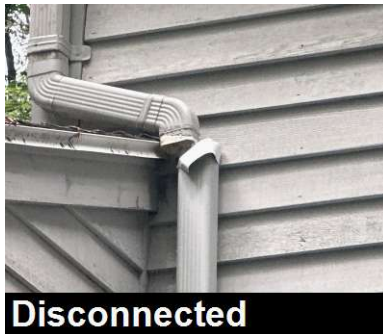
One or more downspouts are disconnected. This will deposit roof water close to the building and can promote water intrusion into the building and could cause settlement of the structure itself. You should have the downspouts reconnected and secured.

**Disconnected**

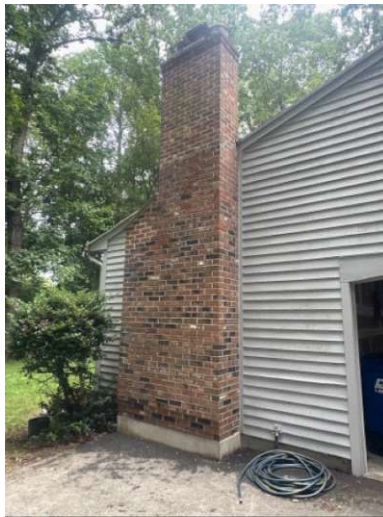
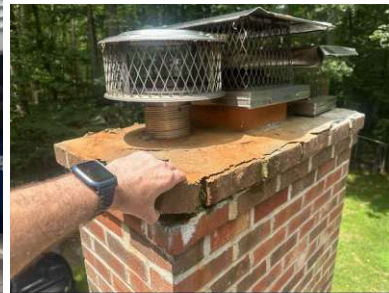
Chimney

A brick chimney is located at the eave edge of the building. The chimney brick is loose and deteriorated. If left unrepaired, the deterioration can continue, leading to higher repair costs and safety hazards. You should have a chimney specialist make necessary repairs. The brick chimney mortar is deteriorated. If the mortar is left to deteriorate further, more serious damage could occur. You should have a qualified mason repoint the chimney as needed. The cap (crown) of the brick chimney is cracked or deteriorated. This can allow water into the masonry, causing deterioration and damage. You should have a qualified masonry contractor repair or replace the cap as needed. There have been previous repairs to the chimney. It is impossible to know whether these were done by a professional Mason or not. You should monitor the chimney for future issues.

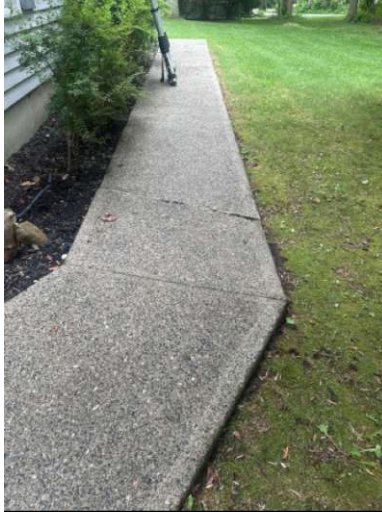
**Walkway**

Some of the walkways are cracked or deteriorated.

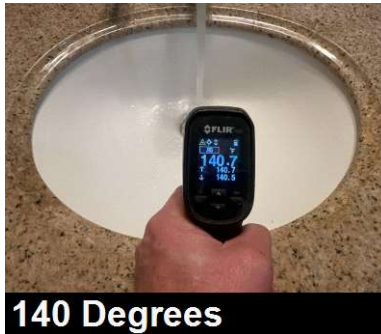
Water temperatures over 125 degrees F can cause severe burns or death from scalds. Children, disabled and elderly persons are at highest risk of being scalded.

**140 Degrees**

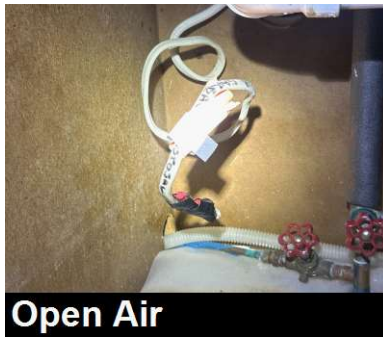
Non-metallic ("Romex") wiring is used in the building. **Wires are terminated in open air. This is hazardous and may cause fire or electrocution. Wires should be terminated in a covered junction box by a qualified electrician.**

**Open Air**

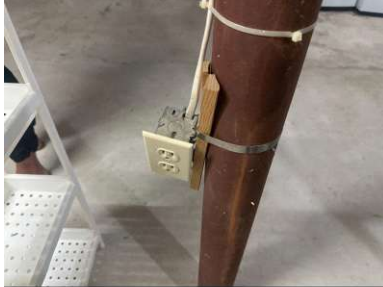
Receptacles are generally of the 3-hole grounding type. One or more receptacles are loose or not properly installed. This could cause a short circuit or poor connection. You should have a qualified electrician repair or replace loose receptacles.

**Amateur Install**

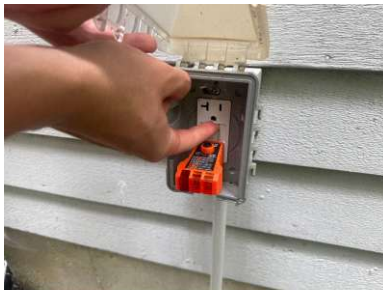
One or more GFCI outlets tripped but could not be reset at the receptacle. This normally means that there is a another GFCI outlet wired in series down the line or the reset is in an electrical panel. You should inquire with the current owner as to how to reset all GFCI outlets.

**Will Not Reset**

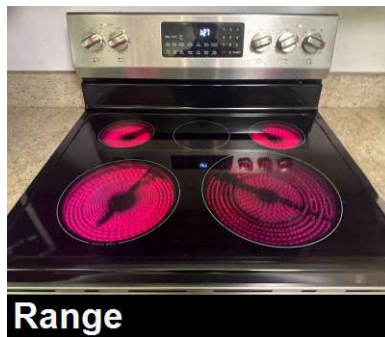
The electric range appears to be functional. **The anti-tip bracket was not installed on the range. This is a safety hazard because the range could tip over and cause burns or injury. You should have the bracket installed according to manufacturer's recommendations.**

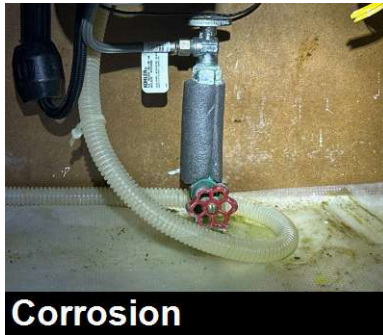
The supply line under the kitchen sink is corroded and may begin leaking. You should have a qualified plumber replace the corroded valves.

**Corrosion**

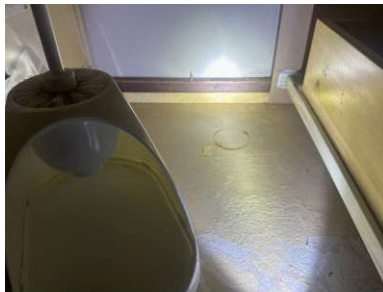
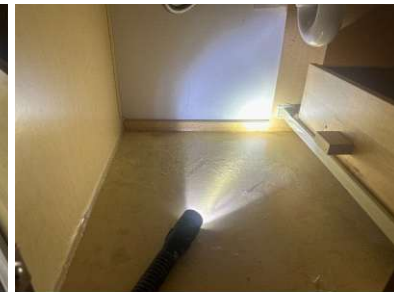
The bath sink faucet is loose. You should have a qualified plumber repair the problem. This can cause serious damage to floors or anything around or below the sink. There was evidence of old staining under the sink. You should monitor these areas in the future for leakage.

**Old Stains**

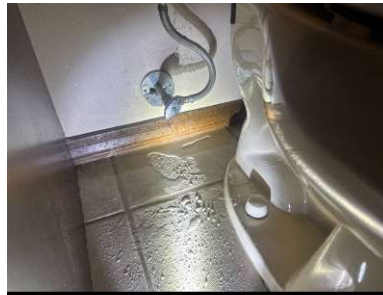
The toilet is leaking in the bath. A leak may cause damage to the floor and any areas below. You should have a qualified plumber repair the leak.

**Leak**

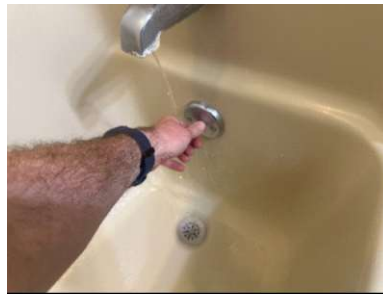
The tub popup drain control is not properly functioning in a bath. You may wish to have a qualified plumber repair the drain control.

**Stopper**

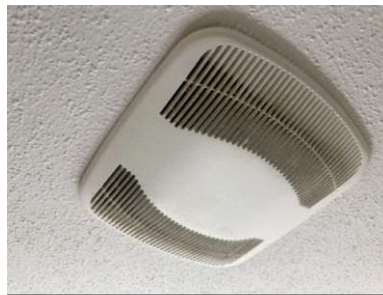
The vent hood from the bath fan is dirty. This may allow moisture to accumulate in the bathroom eventually causing damage or biogrowth. You should clean the hood.

**Dirty**

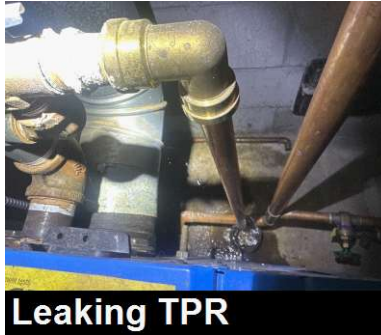
The pressure relief valve is leaking by. The valve may be defective and in need of replacement, or it could be an indication of a problem elsewhere in the system. You should have a qualified boiler technician evaluate and repair as needed.

**Leaking TPR**

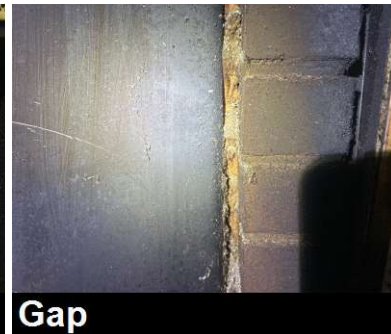
There is a masonry fireplace with a metal firebox. You should have the flue cleaned by a professional chimney service prior to using the fireplace and regularly thereafter, depending on use. Consult with the chimney service for frequency details suited to your use. The damper was tested and appears to be functional. There is a separation between the firebox and the fireplace facing. This is a fire hazard because flames and hot embers will be able to contact combustible materials in the wall. You should have a qualified fireplace specialist properly seal the opening before using the fireplace.

**Gap**

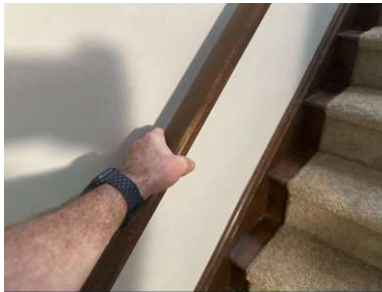
The handrail at the stairs is loose. You should secure the handrail. The space below the handrail at the basement stairway is open. Additionally, these stairs have open risers. These are safety hazards. You should have a qualified contractor make the necessary corrections.

**Loose**

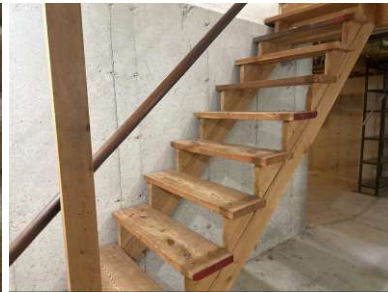
**Basement Stairs**

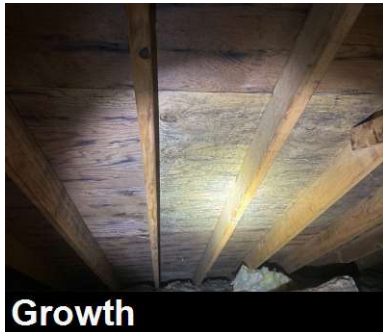
There appears to be suspect microbial growth on the underside of the roof and/or on the rafters. This could lead to deterioration of the wood. This is probably the result of inadequate ventilation or uncontrolled humidity in the building. You should have a qualified contractor evaluate the ventilation and recommend an appropriate solution. You should also have a specialist test for the presence of harmful biogrowth.

**Growth**

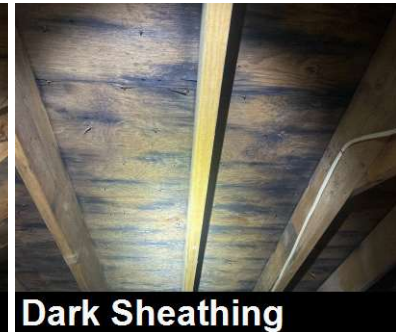
There is darkening on the underside of the roof sheathing which is an indication of slight deterioration from a combination of heat and moisture. This occurs mostly in older homes built with inadequate ventilation.

**Dark Sheathing**

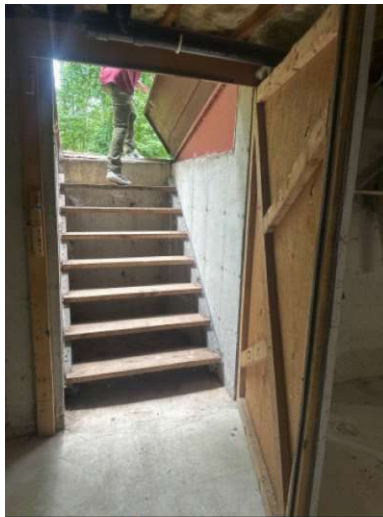
There is no weather tight door at the bulkhead. This could be an energy loss or security concern. You may wish to have a qualified contractor add the appropriate door here.

### Not Water Tight

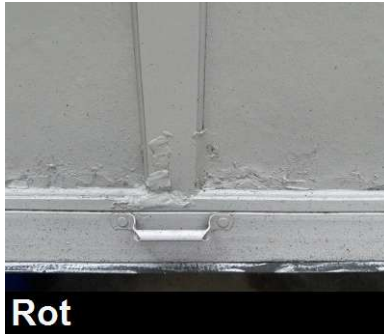
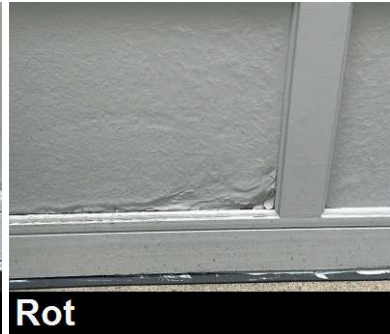
The garage door was operated and it functions as intended. One or more of the panels of the garage door are rotting. You should have the affected sections repaired or replaced by a qualified contractor.

**Rot**

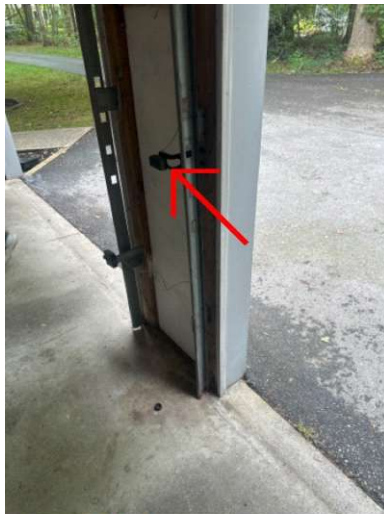
The automatic reverse mechanism functioned properly when tested. You should test the reversing mechanism periodically in accordance with the manufacturer's recommendations. The photo sensors for the garage door opener are mounted more than 6 inches above the floor. This is a safety hazard. You should have a qualified garage door mechanic properly position the sensors.

**Too High**

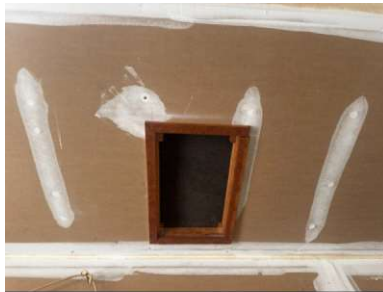
The fire wall in the garage is drywall. There are holes in the garage ceiling or wall. This is a safety hazard. You should ensure that there is a continuous fire rated barrier between the garage and the living space. The door between the garage and the living space does not close automatically. This is a safety hazard. Fumes from vehicles or possibly even fire from the garage could spread more quickly to the living area. You should have a qualified contractor install or repair self closing hinges on this door.

**Hole**

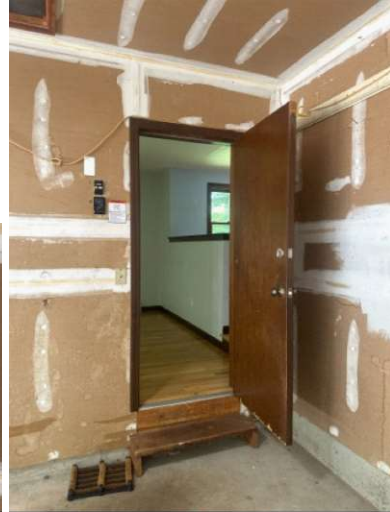
**Not Auto Closing**
