**Anchor Home Inspection**  
16 Deer Trail  
Oakdale CT 06370  
860-961-3213  
AnchorHomeInspection@gmail.com

**Inspection reference: Sample**

# **Confidential Inspection Report**

**July 1, 2025**

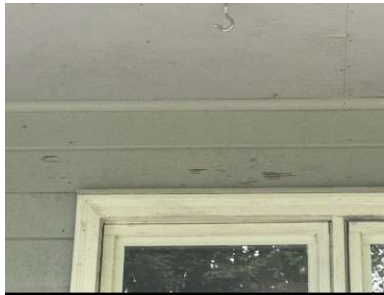
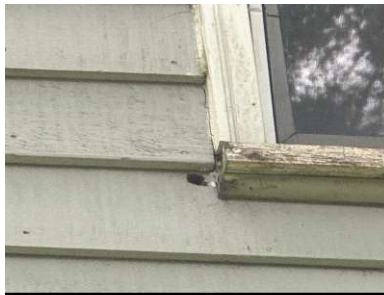
**Siding**

The exterior wall surface is wood board siding. **Sealant is missing or deteriorated where the utility wiring and piping run through the exterior wall. This sealant is necessary to prevent moisture intrusion. You should seal these areas with a sealant suited for this location and use. The siding is damaged at one or more locations. Siding is the protection for the building and any damage or deterioration could allow moisture and weather intrusion, causing further damage and expense. The siding material should be repaired or replaced as needed to make a weather-tight envelope for the building. There is inadequate clearance between the siding and the roof surface. This may allow water to wick into or behind the siding. You should have a qualified contractor trim the siding to give adequate clearance. The paint/stain coating is deteriorated at several locations along the walls. Paint and other coatings are a barrier to help protect the substrate from deterioration due to sunlight and weather elements. A coating should be properly applied to the surfaces in need. The siding is rotted at one or more locations. Siding provides protection against the weather for the structure and interior of the building. The rotted areas should be replaced or repaired permanently with proper materials. There have been amateur repairs at the siding. You should monitor these areas.**

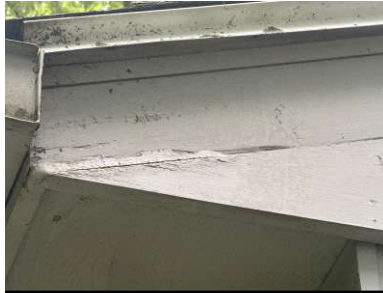
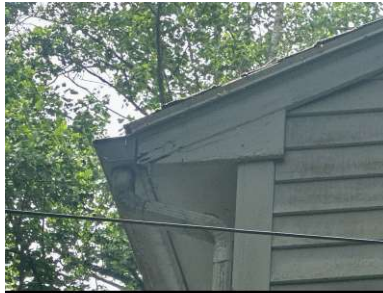
**Eaves**

The eaves are wood. There is rot at the eaves. Rotted eaves can allow the entry of moisture and pests which could cause further deterioration. The rotted portions should be repaired or replaced.

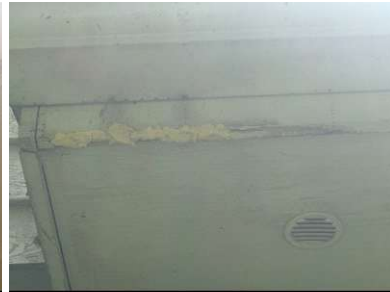
**Facias**

The fascia is wood. There are rotted sections of the fascia near . The rotted areas could allow for the entry of moisture or insects and can lead to further damage. You should have the damaged sections replaced.

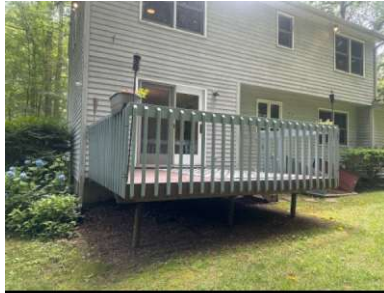
**Deck**

There is a deck attached to the home. The deck is carpet covered. This may trap moisture and lead to wood rot. We were unable to determine the condition of the material under the carpet.

The deck railings are loose. Loose railings will not provide protection from falls. The railing should be secured or replaced.

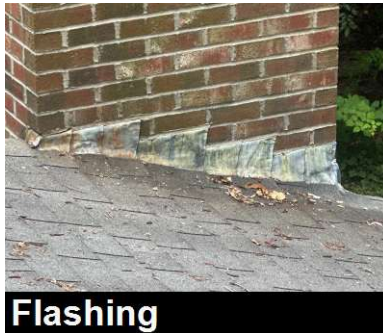
**Flashing**

There are visible metal flashings on the home. All flashings require periodic maintenance.

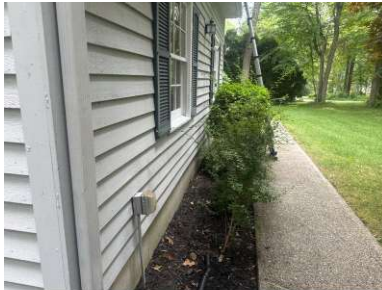
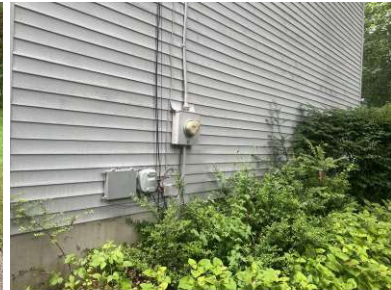
**Vegetation**

There is vegetation such as trees and shrubs that is close to or in contact with the building. This vegetation can retain dampness next to the building and can attract insects. The vegetation should be kept trimmed away from the building.

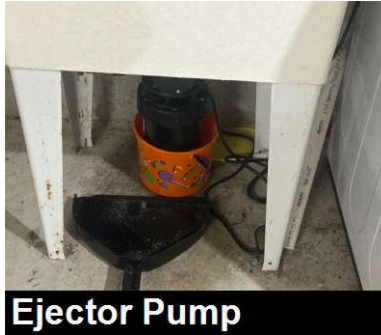
**Ejector Pump**

There is an ejector lift pump serving the plumbing fixtures that are below the level of the building sewer line. Ejector lift pumps are used to pump waste into the building sewer line. Since they depend on electricity, you should avoid using the plumbing fixtures served by a lift pump during power interruptions. Ejector lift pumps should be professionally serviced every 5 years.

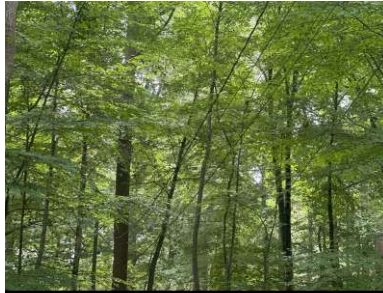
### In Trees

The building is served by what appears to be a 200 amp 120/240 volt overhead electric service. **The overhead conductors from the pole to the building pass through or under trees. These wires could be damaged by the trees rubbing on them, which could create a shock hazard or service interruption. You should contact the electric utility company and have the trees trimmed and the wires inspected or repaired.**

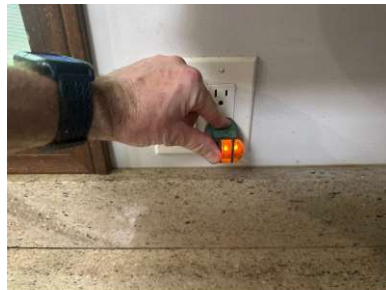
**Non-GFCI**

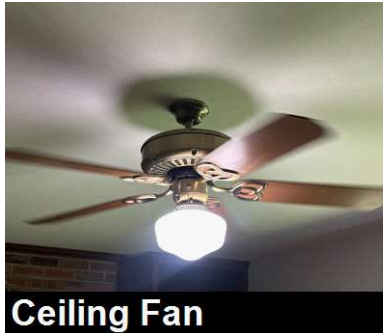
**Ceiling Fan**

mounting of these fans is beyond the scope of this inspection. You should have a qualified electrician check the mounting of ceiling fans.

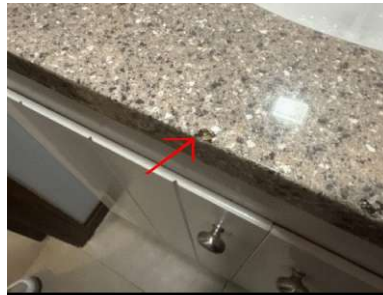
**Damaged**

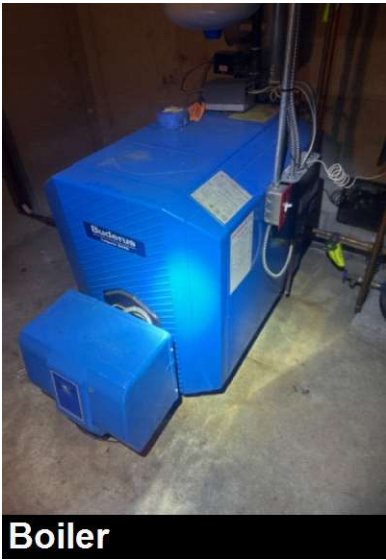
Boiler

Heat is provided by a 18 year old oil fired boiler. The boiler was tested and appears to be functional.

The pressure relief valve is leaking by. The valve may be defective and in need of replacement, or it could be an indication of a problem elsewhere in the system. You should have a qualified boiler technician evaluate and repair as needed.

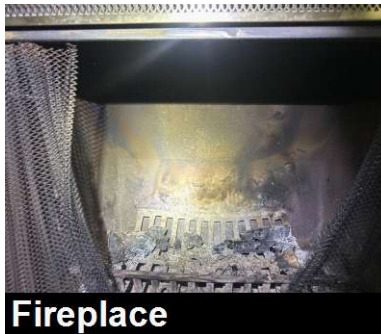
**Fireplace**

There is a masonry fireplace with a metal firebox. You should have the flue cleaned by a professional chimney service prior to using the fireplace and regularly thereafter, depending on use. Consult with the chimney service for frequency details suited to your use. The damper was tested and appears to be functional. There is a separation between the firebox and the fireplace facing. This is a fire hazard because flames and hot embers will be able to contact combustible materials in the wall. You should have a qualified fireplace specialist properly seal the opening before using the fireplace.

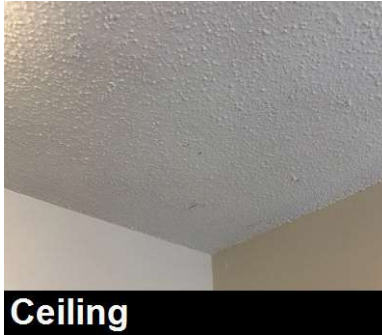
A textured coating has been applied to some or all of the ceilings. Textured paint is sometimes used to hide cracks.

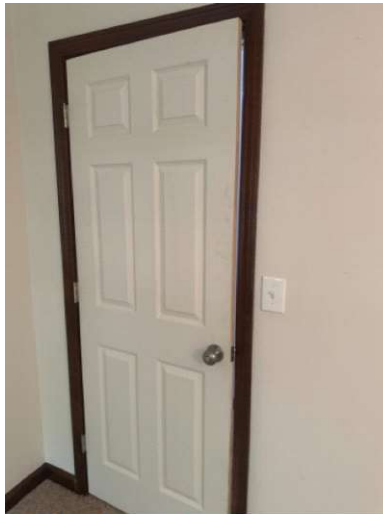
**Will Not Close**

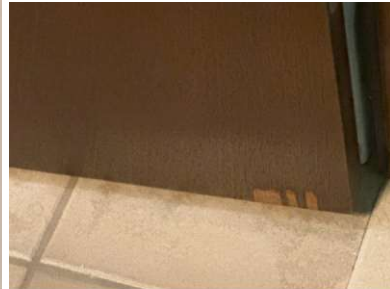
**Minor Damage**

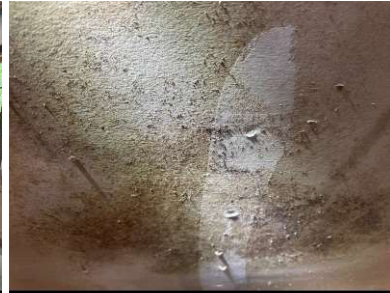
**Garage**

The garage was entered and inspected. There appears to be bio-growth (mold or mildew) present in the garage. This is a potential health concern and could lead to deterioration of surfaces and materials. You should consult a qualified specialist to correct the problem.

**Growth**
